ANALYZING THE EFFECTS OF FIRE ON THE STABILITY OF ECCENTRICALLY BRACED HIGH-RISE STEEL STRUCTURES

Abstract: In this research, the evaluation of progressive damage due to fire in high-rise steel structures with diverging braces has been done. For this purpose, a frame with two openings and one floor has been selected from the reference article, and the fire scenario was implemented in one of the openings, and the horizontal displacement of the middle of the structure and the top of the column with the displacement values obtained from the reference article, comparison and accuracy. Was measured in the continuation of the research, 24 samples were analyzed in 3 categories. There are 15 floors in the first category of samples, 20 floors in the second category of samples, and 25 floors in the third category of samples. In each category, the first 4 samples are without braces and the second 4 samples are with divergent braces. In each category, the fire scenario was in the middle column of the first floor in the first sample, in the side column of the first floor in the second sample, in the middle column of the middle floor in the third sample, and in the side column of the middle flo

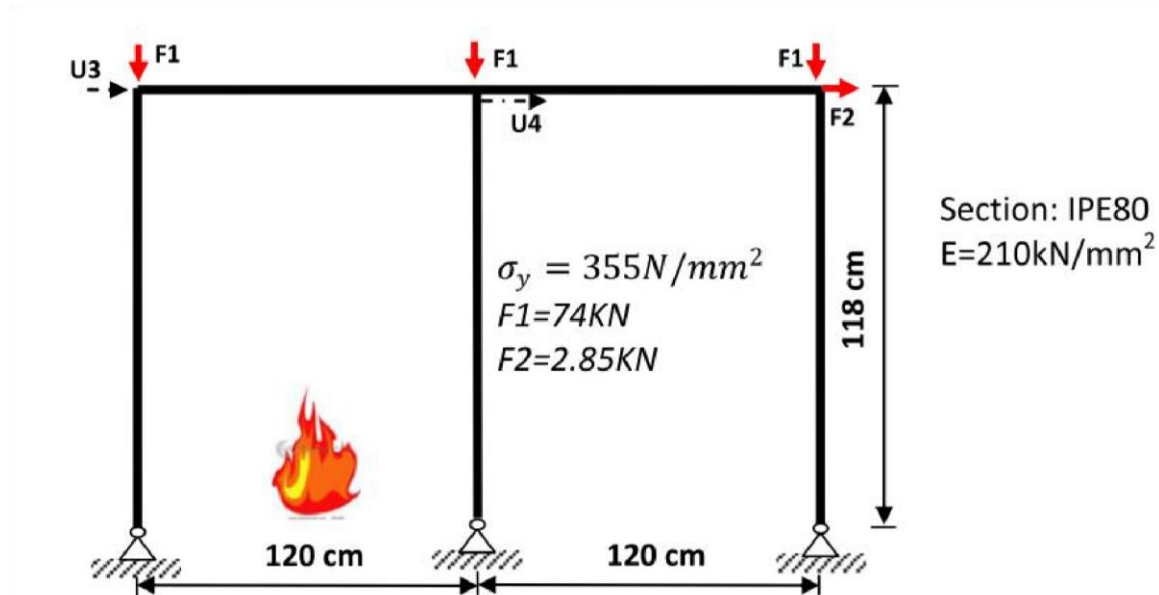
Figure 1: Specifications of the validation sample [1].

As seen in Figure 1, the verification sample is a frame with two openings and one floor, the dimensions of the opening are 120 cm and the height of each floor is 118 cm, and its cross section is IPE80 for It is a beam and a column. A fire has been made in the left opening. For modeling in the validation section, a two-dimensional beam model has been used in Abaqus, and a schematic of the drawing geometry in Abaqus software is presented in Figure 2.

The reference article was used to verify the results. The specifications of the model analyzed in this article are presented in Figure 1.

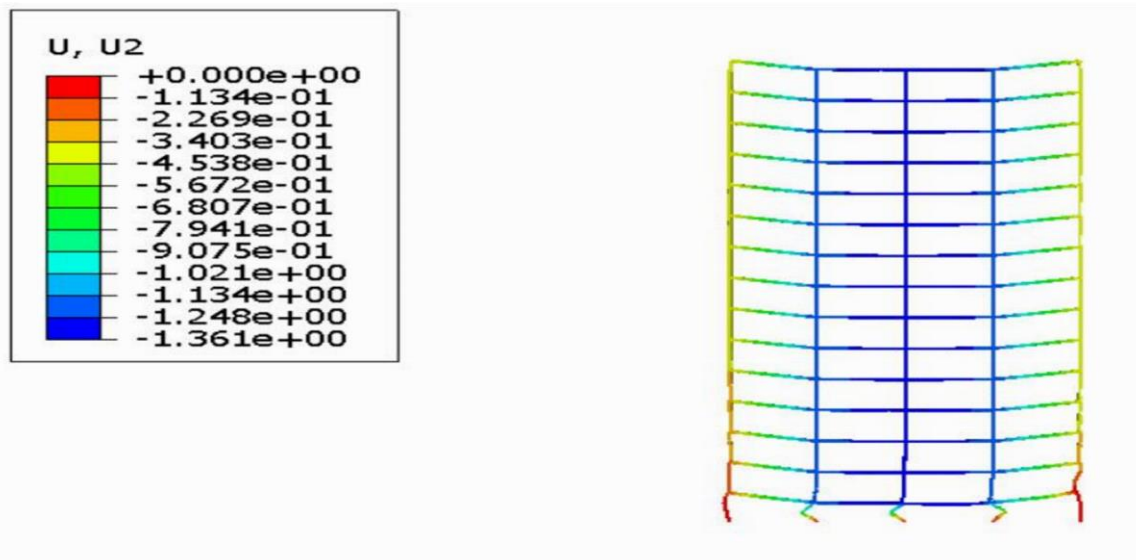
Figure 3: The largest displacement in thermal analysis in model number 1 (simple frame, 15-floor model, fire place in the middle of the first floor of the structure).

A schematic of the deformation in models 1 to 4 is presented in Figures 3 to 6. In these models, the structure is 15 stories without braces, in model number 1, the fire place is on the first and middle floor column, in model number 2, the fire place is on the first floor column and side, in model number 3, The place of fire is on the column of the middle and middle floor, and in model number 4, the place of fire is on the column of the middle floor and on the side of the structure.

1- In the 15-floor structure without braces (examples 1 to 4), the maximum displacement is related to model number 1 and 2, both of these structures are caused by fire and thermal load on its column. It has undergone many deformations and progressive deterioration. In model number 3 and 4, the structure has been able to resist the incoming loads to some extent and the reason for this is that the loads on the column in the middle floor are much less than the lower floor and for this reason by removing one column As a result of the fire, the structure has been able to withstand the loads with the help of the rest of the columns and the structure has not undergone many deformations. Therefore, in a 15-floor structure without the worst scenario, removing the column in the lower middle floor, then the lower side floor, and then the middle floor of the middle column, and finally, the least damage is related to the removal of the column in the middle and side floors.

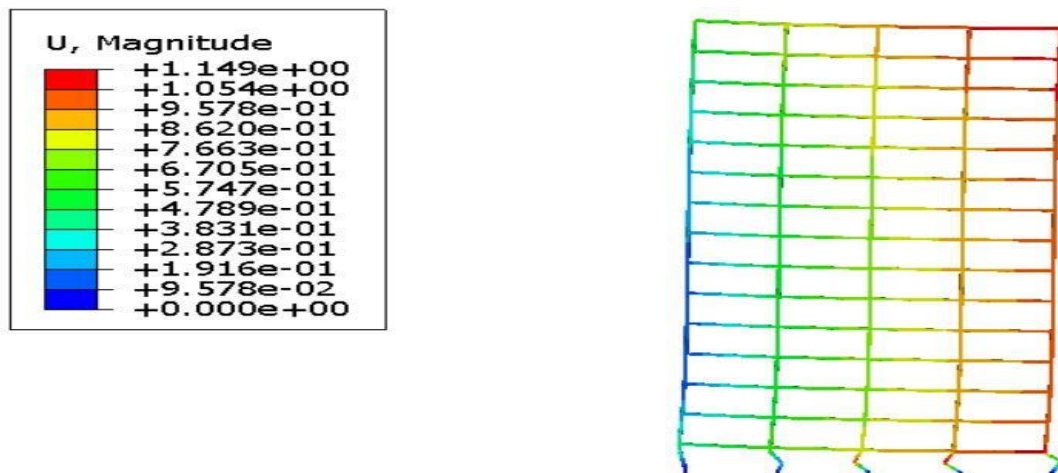
Figure 4: The largest displacement in thermal analysis in model number 2 (simple frame, 15-floor model, fire location next to the first floor of the structure)

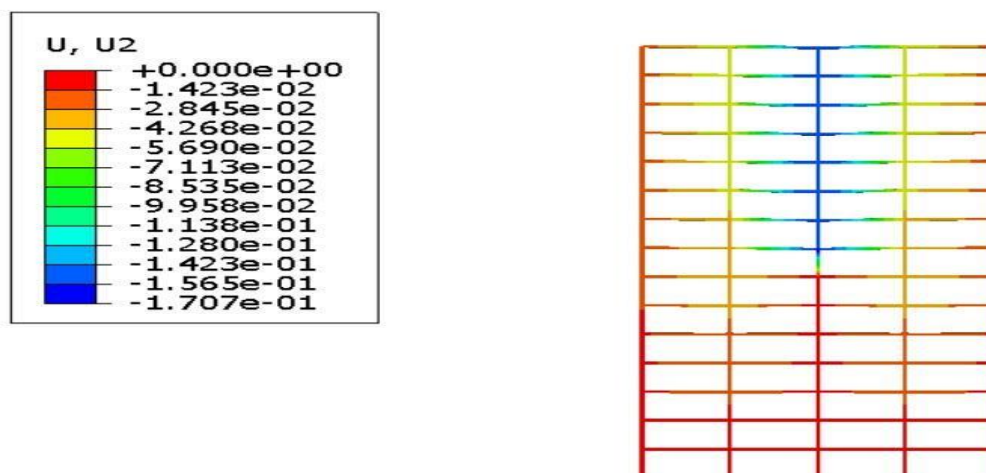
Figure 5: The largest displacement in thermal analysis in model number 3 (simple frame, 15-floor model, fire place in the middle of the middle floor of the structure)

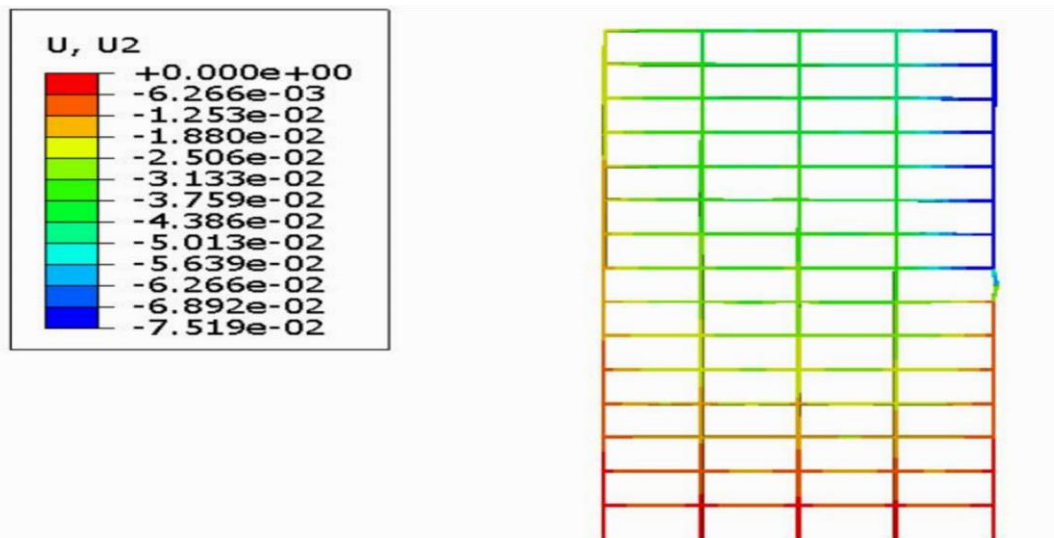
Figure 6: The highest displacement in thermal analysis in model number 4 (simple frame, 15-floor model, fire location next to the middle floor of the structure)

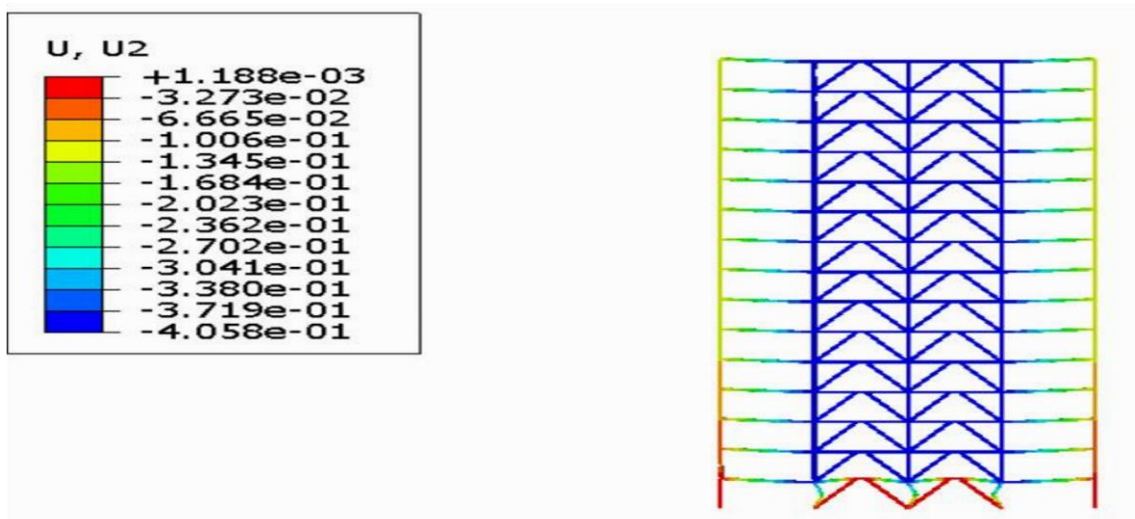
Figure 7: The highest displacement in thermal analysis is in model number 5 (frame with divergent brace, 15-floor model, fire place in the middle of the first floor of the structure)

4.2.2. The results related to the 15-floor structure with braces (model number 5 to 8) A schematic of the deformation in models 5 to 8 is presented in Figure 7 to 10. In these models, the structure has 15 floors and has braces. In model number 5, the fire location is on the column of the first floor in the middle, in model number 6, the fire location is on the column of the first floor and on the side, in model number 7, the location The fire is on the column of the middle and middle floor and in model number 8, the place of fire is on the column of the middle floor and on the side of the structure.

2- In the samples analyzed in the 15-floor structure and with divergent braces in models 5 to 8, in all 4 models, the maximum amount of displacement due to the application of heat in the models compared to the simple frame without divergent braces with a decrease has been In this category, except for sample number 5, in the rest of the samples, the structure has been able to show good resistance, and with increasing temperature and removal of a column, progressive failure has occurred only in structure number 5.

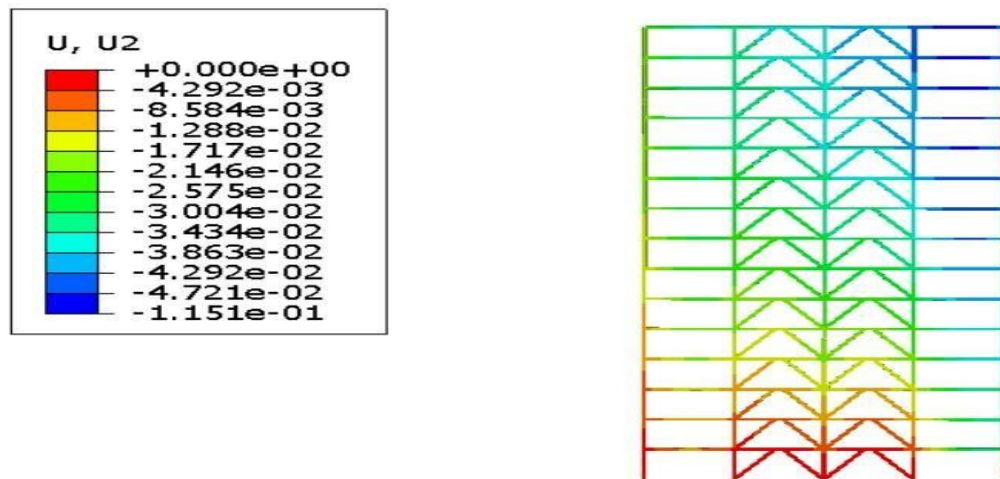
Figure 8: The highest displacement in thermal analysis in model number 6 (frame with divergent brace, 15-floor model, fire location next to the first floor of the structure)

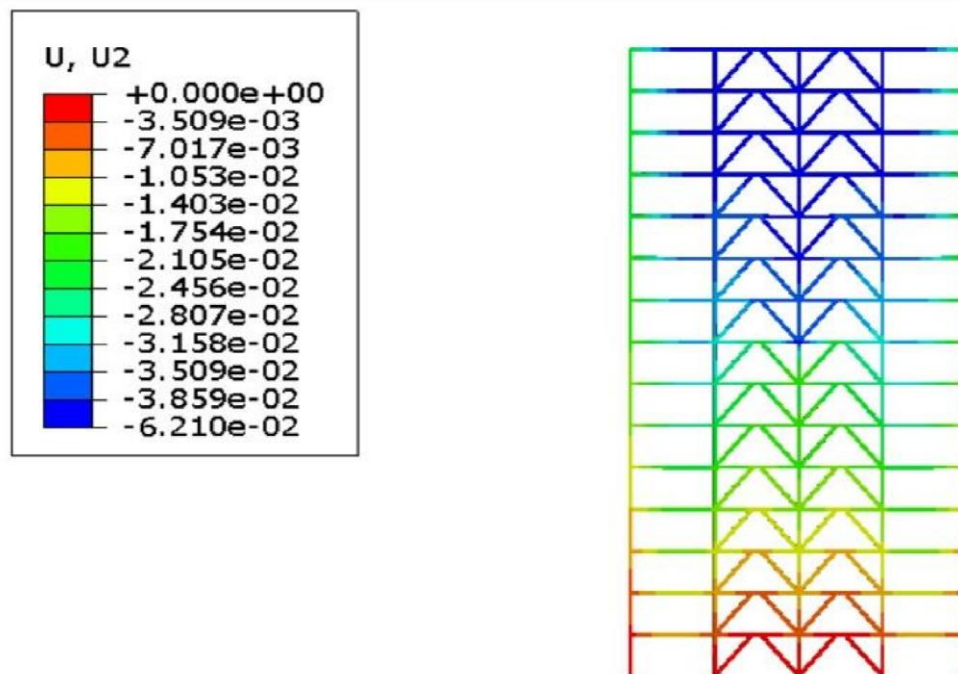
Figure 9: The highest displacement in thermal analysis in model number 7 (frame with divergent brace, 15-floor model, fire location in the middle of the middle floor of the structure)

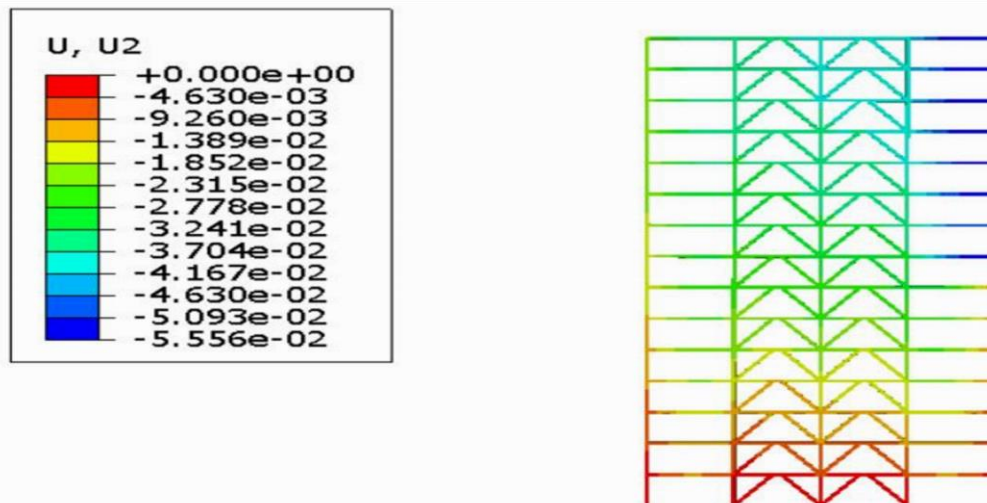
Figure 10: The highest displacement in thermal analysis is in model number 8 (frame with divergent brace, 15-floor model, fire location next to the middle floor of the structure).

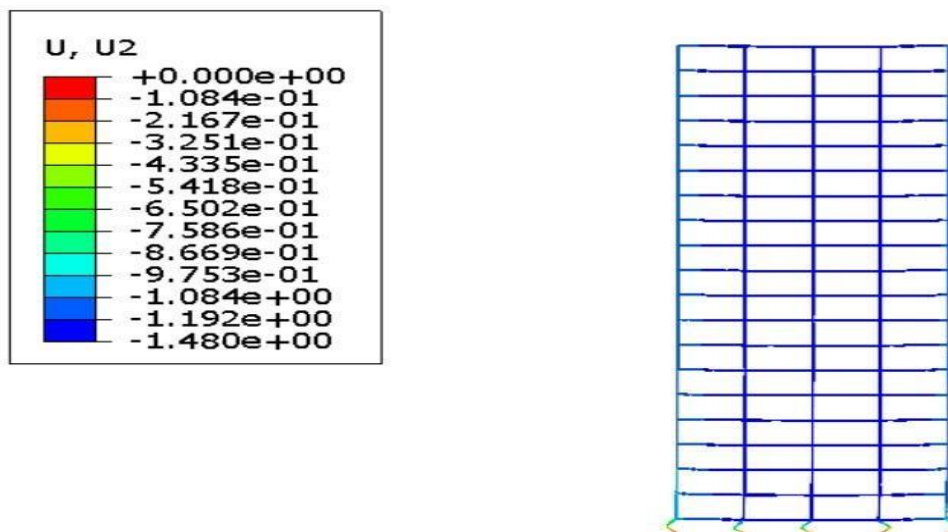
Figure 11: The highest displacement in thermal analysis in model number 9 (simple frame, 20-floor model, fire place in the middle of the first floor of the structure)

A schematic of the deformation in models 9 to 12 is presented in Figure 11 to 14. In these models, there is a 20-floor structure without braces, on which 4 fire scenarios similar to models 1 to 4 have been applied, the first two samples of the column of the first floor and the second two samples of the column of the tenth floor are exposed to fire. is placed).

3- In samples number 9 to 12, there were 20-floor structures without braces, and both structures 9 and 10, due to the fire and the thermal load on the column, suffered large deformations and progressive damage. has been In model number 11 and 12, the structure has been able to withstand the loads to a large extent and the reason for this is that the loads on the column in the middle floor are much less than the lower floor and for this reason by removing a Due to the fire of the structure, the column has been able to resist the loads with the help of the other columns and the structure did not undergo many deformations. In these models, compared to the 15-floor models, in all 4 models, the deformations have increased up to 40% due to the increase in loads on the structure due to the increase in height, and samples 11 and 12 also have displacements. They are a little upright, but they are prone to collapse due to progressive damage

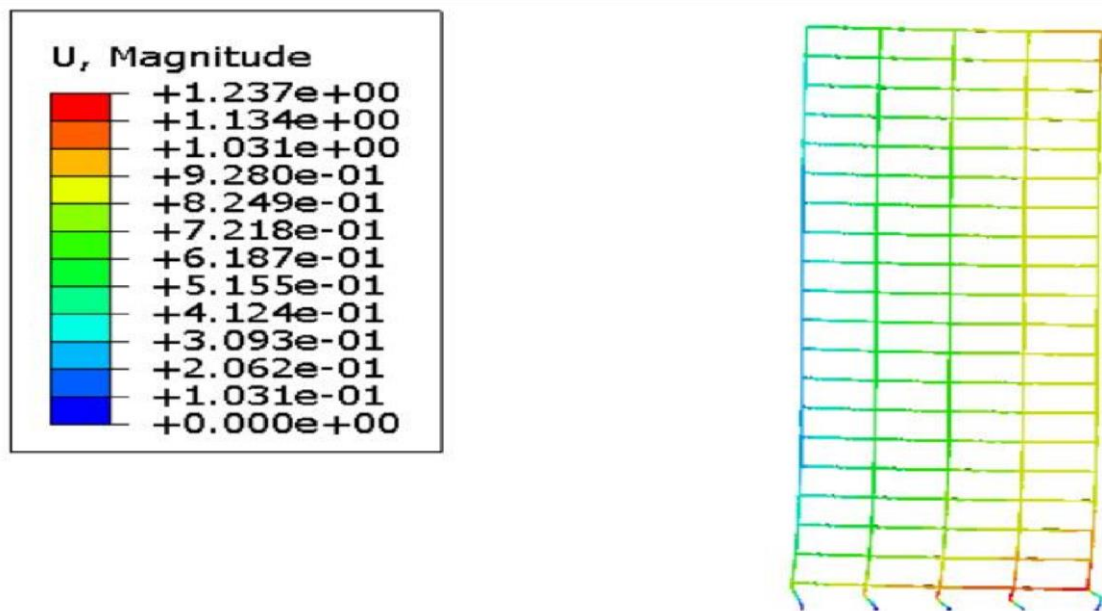
Figure 12: The highest displacement in thermal analysis in model number 10 (simple frame, 20-floor model, fire location next to the first floor of the structure)

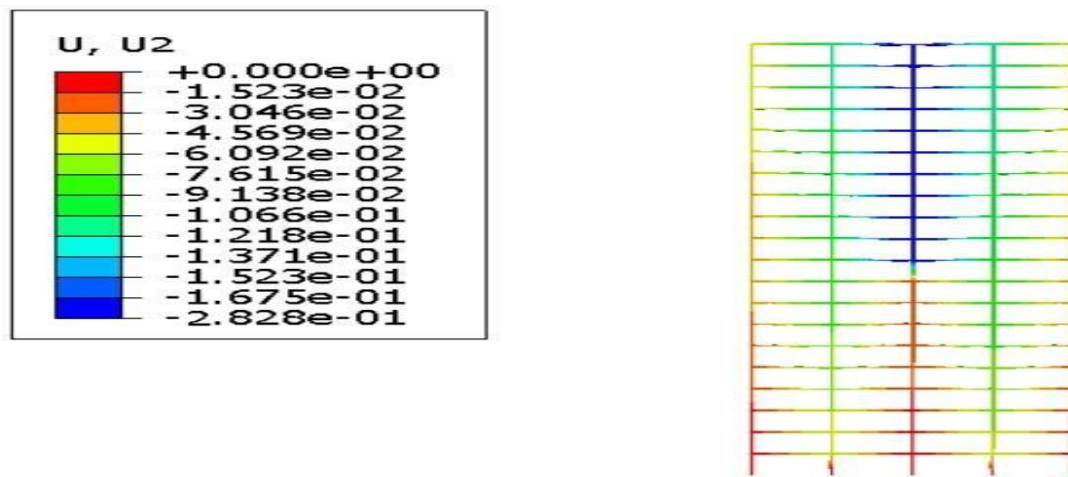
Figure 13: The highest displacement in thermal analysis in model number 11 (simple frame, 20-floor model, fire location in the middle of the middle floor of the structure)

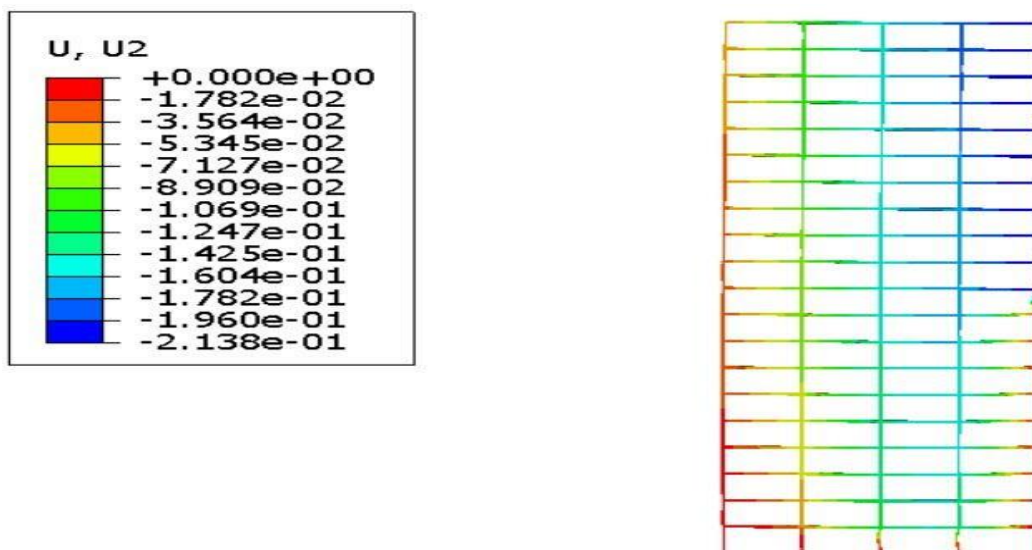
Figure 14: The highest displacement in thermal analysis in model number 12 (simple frame, 20-floor model, fire location next to the middle floor of the structure)

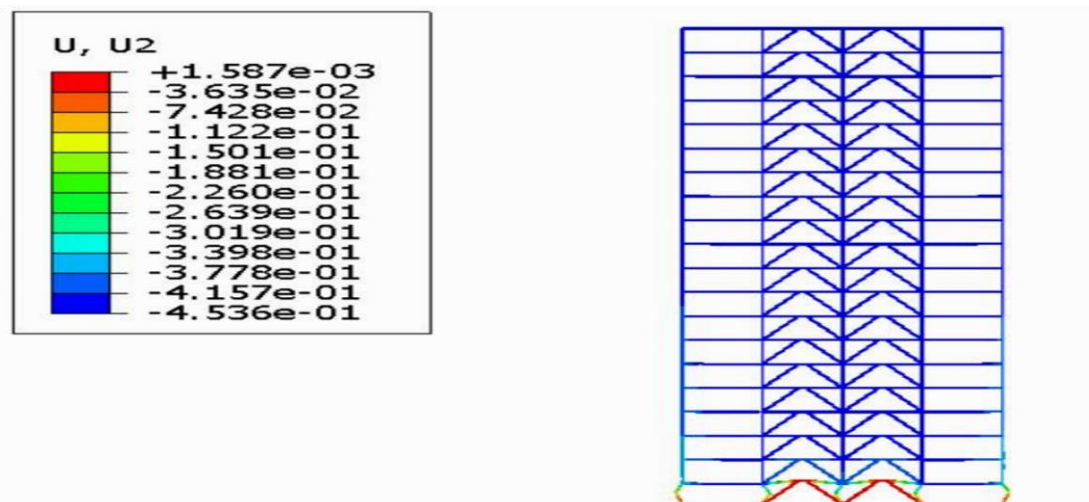
Figure 15: The highest displacement in thermal analysis in model number 13 (frame with diverging brace, 20-floor model, fire place in the middle of the first floor of the structure)

4.2.4. The results related to the 20-floor structure with braces (model number 13 to 16) A schematic of the deformation in models 13 to 16 is presented in Figure 15 to 18. In these models, the structure has 20 floors and has braces. In model number 13, the fire location is on the column of the first floor in the middle, in model number 14, the fire location is on the column of the first floor and on the side, in model number 15, the location The fire is on the column of the middle and middle floor and in model number 16, the place of fire is on the column of the middle floor and on the side of the structure.

4- In samples 13 to 16, in all 4 models of the 20-floor structure, the amount of maximum displacement due to the application of heat in the models compared to the simple frame without diverging braces was accompanied by a good reduction. In this category, except for sample number 13 and 14, in the rest of the samples, the structure has been able to show good resistance, and with the increase in temperature and the removal of a column, progressive failure has occurred in structures 13 and 14, and samples 15 and 16 have shown resistance. It has shown good resistance to progressive damage caused by fire. In this category, compared to the 15-floor samples with diverging braces, the amount of displacement has increased by 40%.

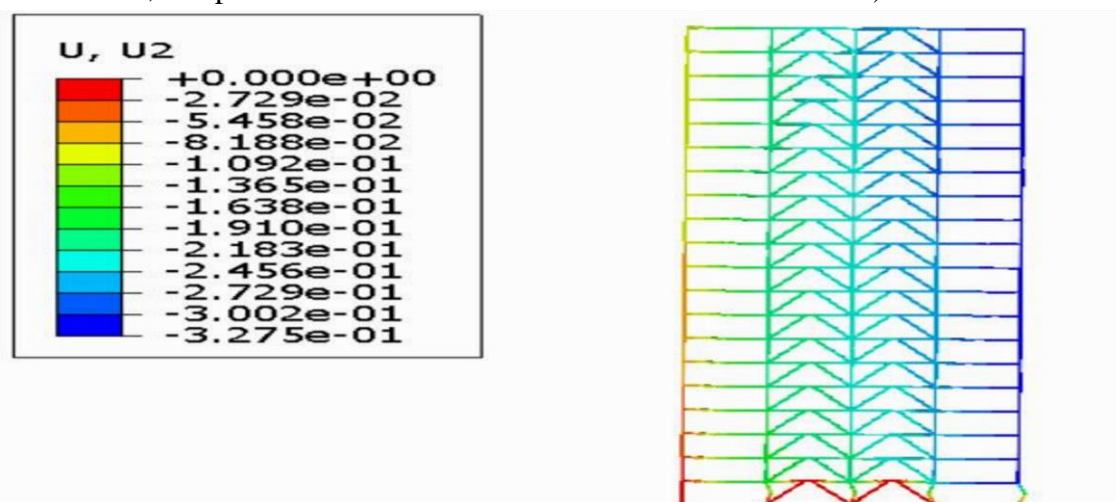
Figure 16: The largest displacement in thermal analysis in model number 14 (frame with divergent brace, 20-floor model, fire location next to the first floor of the structure)

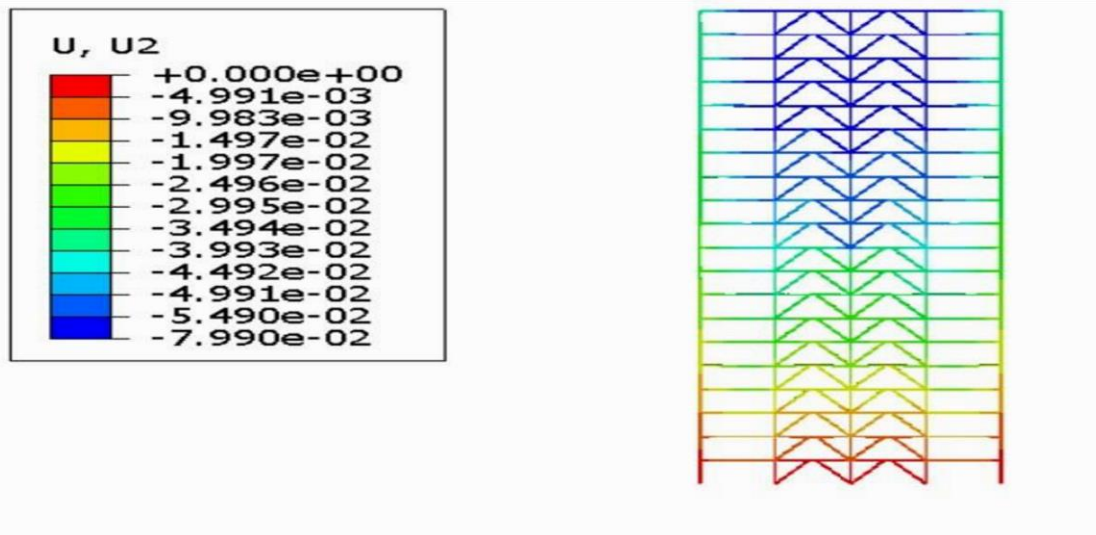
Figure17: The highest displacement in thermal analysis in model number 15 (frame with divergent brace, 20-floor model, fire place in the middle of the middle floor of the structure)

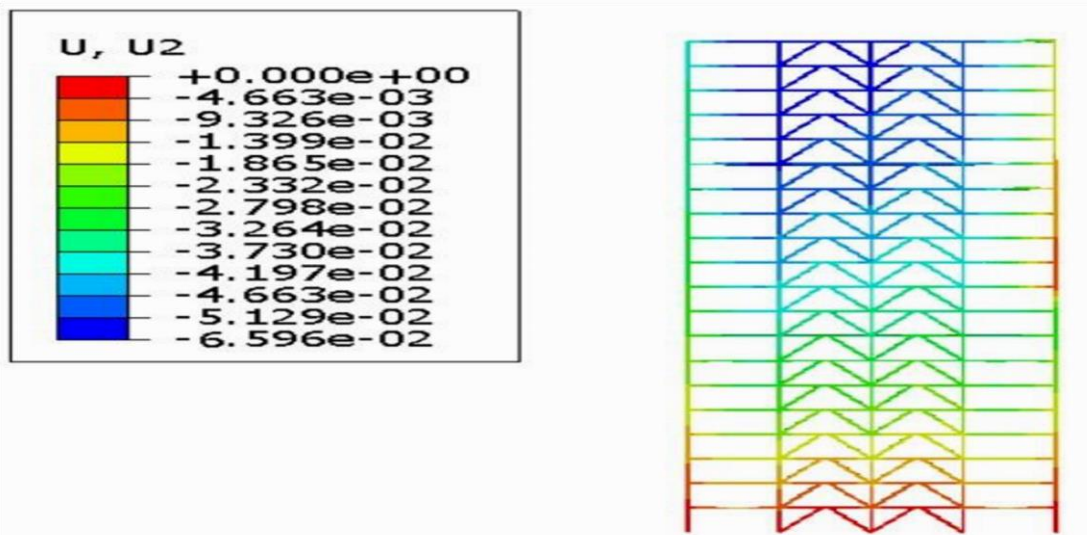
Figure 18: The highest displacement in thermal analysis in model number 16 (frame with divergent brace, 20-floor model, fire location next to the middle floor of the structure)

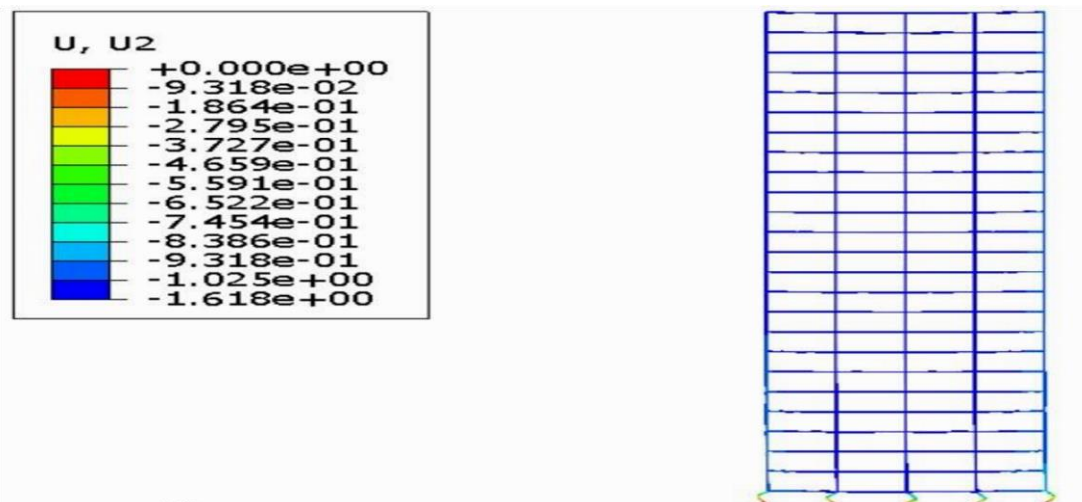
Figure 19: The highest displacement in thermal analysis is in model number 17 (simple frame, 25-floor model, fire place in the middle of the first floor of the structure).

In this section, the results related to models 17 to 20 are presented. In these models, there is a 25-floor structure without braces, on which 4 fire scenarios similar to models 1 to 4 have been applied, the first two samples of the column of the first floor and the second two samples of the column of the thirteenth floor are exposed to fire. is placed). The results of the maximum displacement are presented in Figures 19 to 22.

5- In the structures with 25 floors and without braces in all the samples, the structures have undergone many deformations and progressive damage due to the fire and the thermal load applied to its columns.

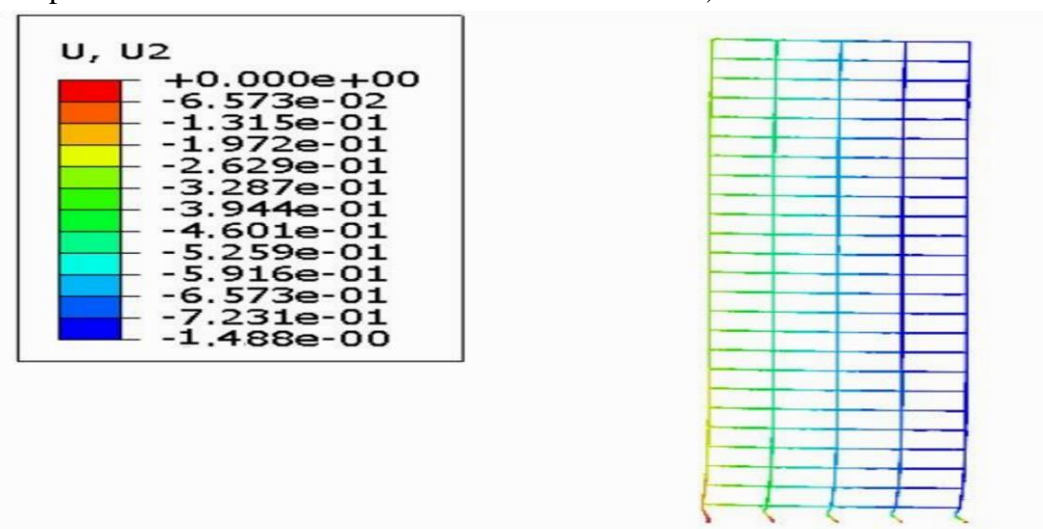
Figure 20: The highest displacement in thermal analysis in model number 18 (simple frame, 25-floor model, fire location next to the first floor of the structure)

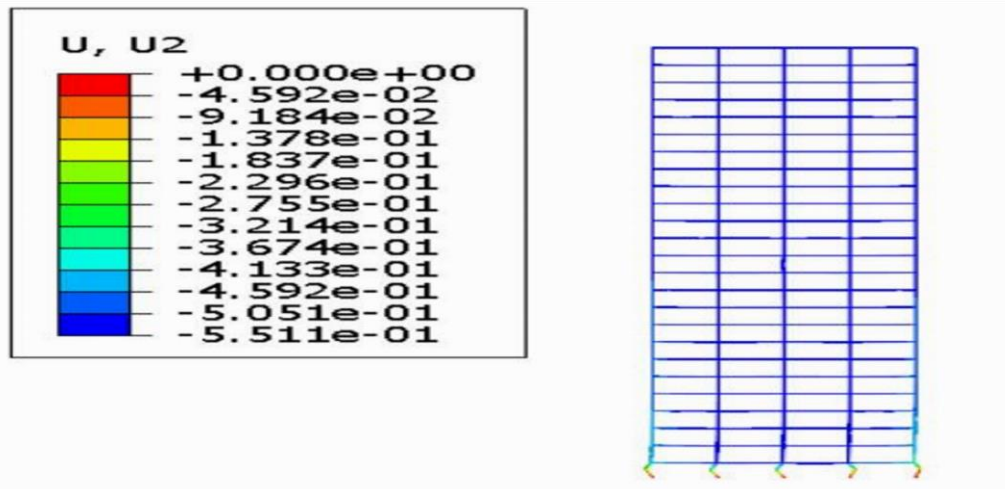
Figure 21 : The highest displacement in thermal analysis in model number 19 (simple frame, 25-floor model, fire place in the middle of the middle floor of the structure)

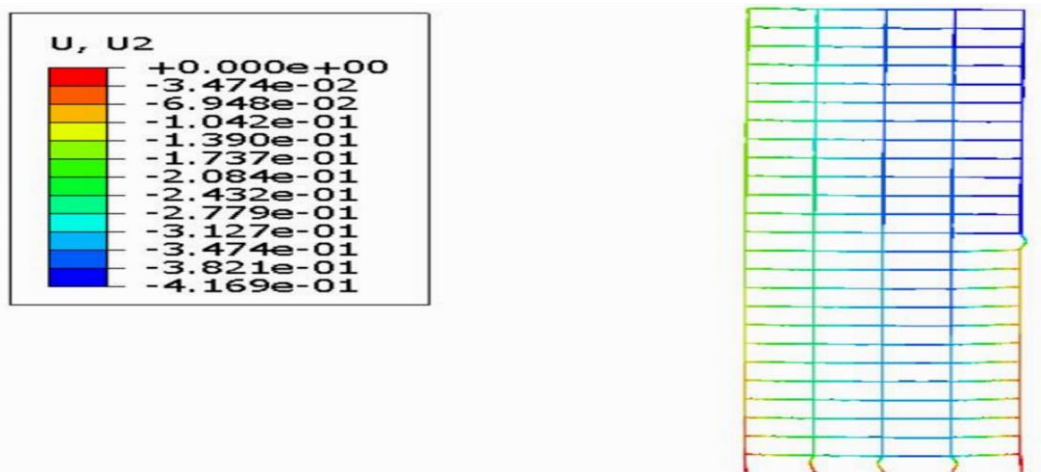
Figure 22: The highest displacement in thermal analysis in model number 20 (simple frame, 25-floor model, fire location next to the middle floor of the structure)

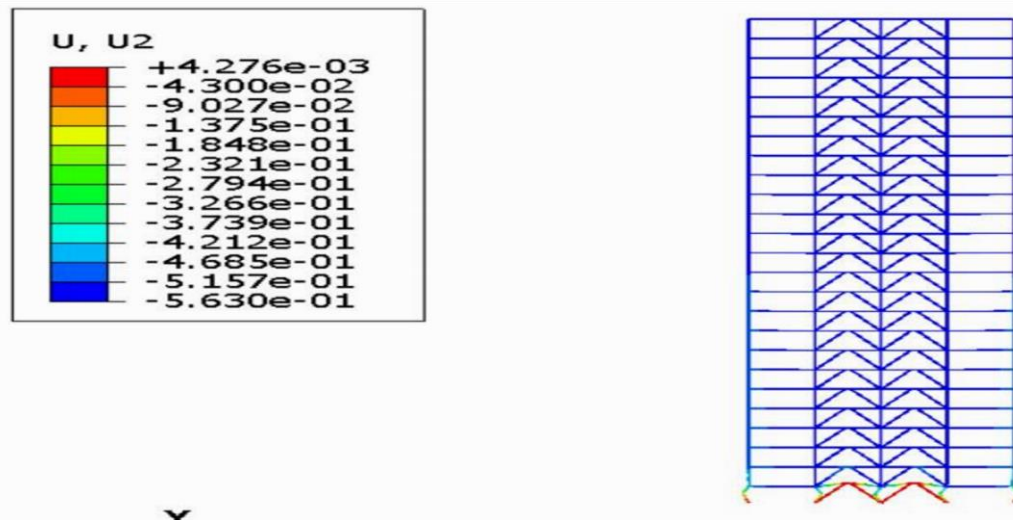
Figure 23: The highest displacement in thermal analysis in model number 21 (frame with divergent brace, 25-floor model, fire place in the middle of the first floor of the structure)

A schematic of the deformation in models 21 to 24 is presented in Figure 23 to 26. In these models, the structure has 25 floors and has braces, in model number 21, the place of fire is on the column of the first floor in the middle, in model number 22, the place of fire is on the column of the first floor and on the side, in model number 23, the place The fire is on the column of the middle and middle floor and in model number 24, the place of fire is on the column of the middle floor and on the side of the structure.

accompanied by a good reduction, except for sample number 21 and 22, in the rest of the samples, the structure has been able to show good resistance, and with the rise in temperature and the removal of a column, progressive damage has occurred in structures 21 and 22, and samples 23 and 24 have good resistance to progressive damage caused by fire from has shown itself. In this category, compared to the samples of 15 and 20 floors with diverging braces, the amount of displacement has increased by 30%.

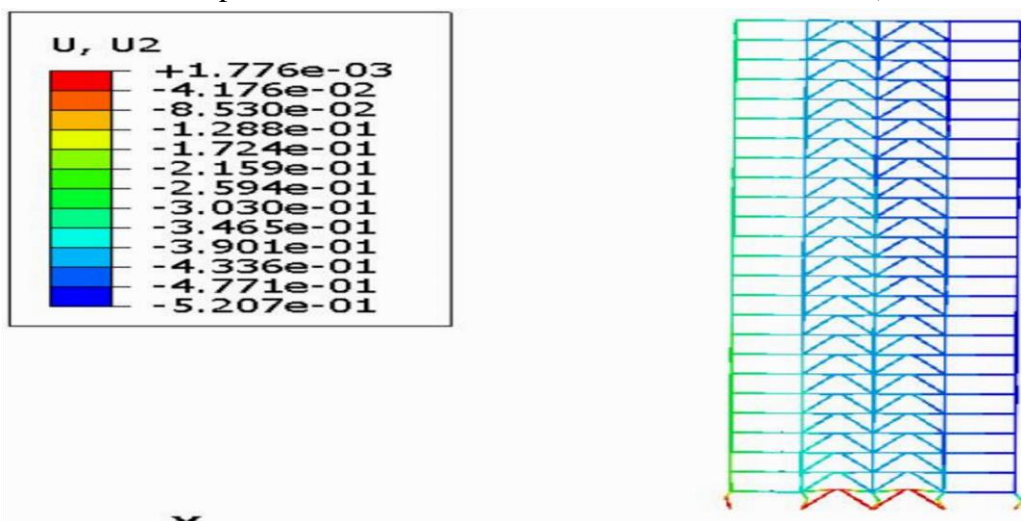
Figure 24: The highest displacement in thermal analysis in model number 22 (frame with divergent brace, 25-floor model, fire location next to the first floor of the structure)

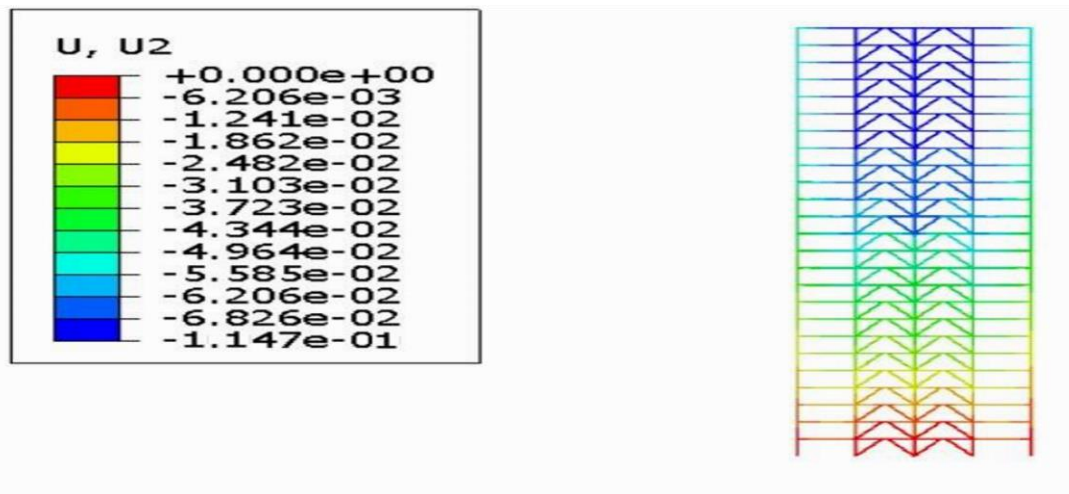
Figure 25: The highest displacement in thermal analysis in model number 23 (frame with divergent brace, 25-floor model, fire location in the middle of the middle floor of the structure)

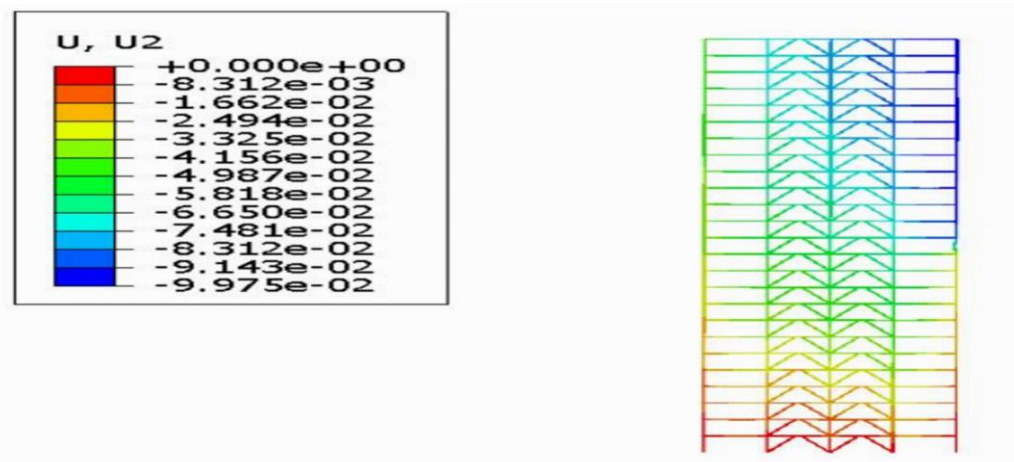
Figure 26: The highest displacement in thermal analysis is in model number 24 (frame with divergent brace, 25-floor model, fire location next to the middle floor of the structure)
