# **DESIGN AND IMPLEMENTATION OF A RESIDENTIAL CONSTRUCTION QUALITY ASSESSMENT SYSTEM FOR SOUTH AFRICA**

**Kabelo Thulani Maseko**

Department of Civil Engineering, University of Johannesburg, Doornfontein Campus, Johannesburg, South Africa

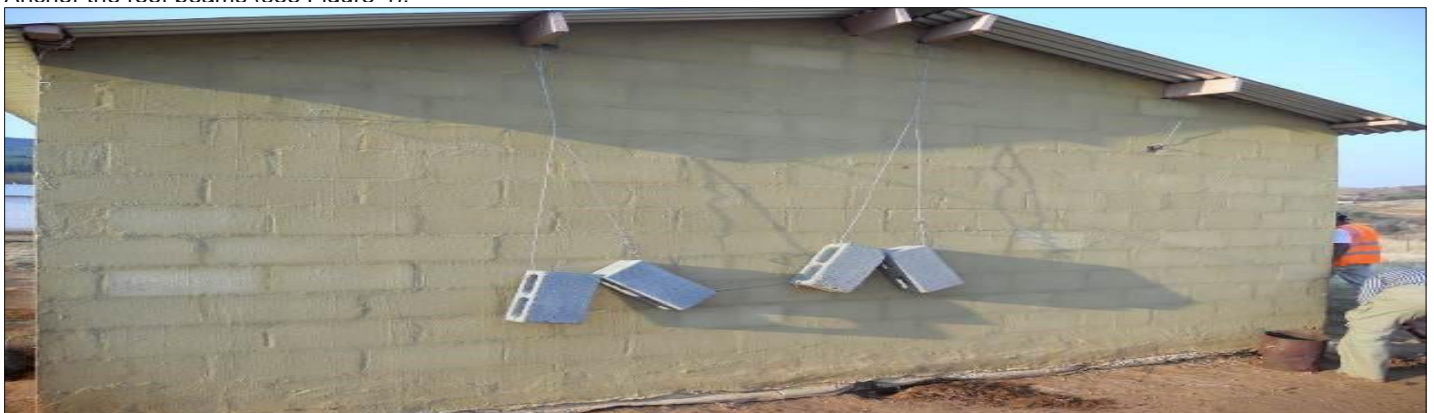
Figure 4 : Typical roof anchoring system used for low-income houses

Of further interest to observe is the comparison of the quality of building elements of the houses. The building elements and the sub-elements associated with these elements were defined in Figure 2 and Table 2. Each building element has a score, and when aggregated with other elements, it gives an overall score for the house. For the low-income houses, the average quality score for the roofs and walls was 55% and 65%, respectively. This was not surprising, as most of the corrugated (IBR) roof sheets commonly used for low-income houses were torn, and as a result, the roofs were leaking within six months. Some of the roofs had boulders on top to prevent them from wind uplift, or cement blocks were used to

Anchor the roof beams (see Figure 4).

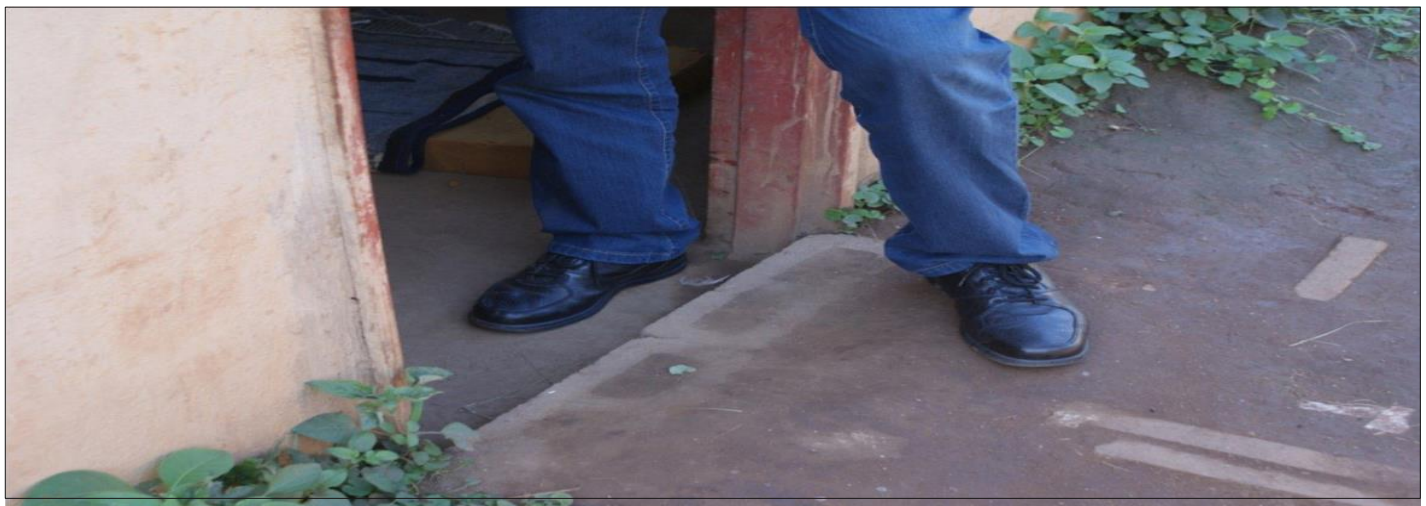
Figure 7: Example of poor substructure in low-income houses
